**Tree Inventory and Preservation Plan Report
450 Dufferin Street
Toronto, Ontario**

11 October 2022

KUNTZ FORESTRY CONSULTING INC. Project P3494

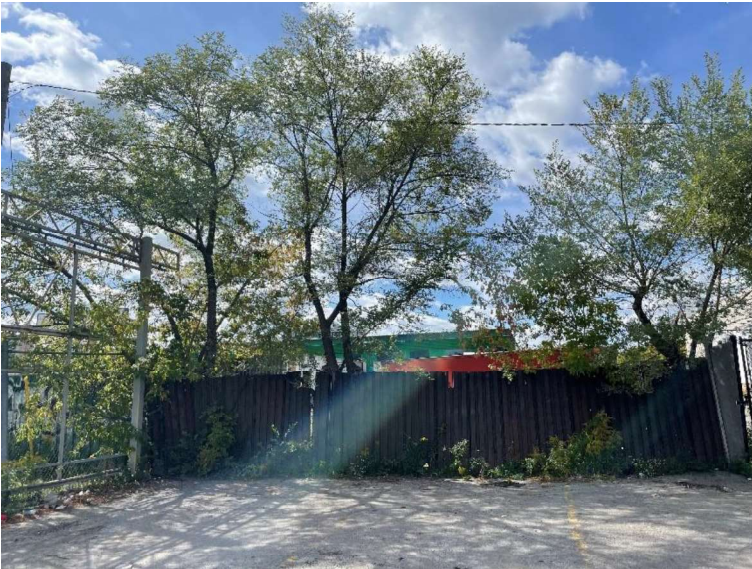
It should be noted that all trees identified for removal are in poor to poor-fair condition as it relates to the tree's trunk integrity owing to moderate to heavy inclusion of the existing fence in the trees' trunks and various other defects, as described in Table 1.

Tree #	Common Name	Scientific Name	DBH	TI	CS	CV	CDB	mTPZ	Cat.	Comments	Action
A	Manitoba Maple	<i>Acer negundo</i>	~16	P	P	PF	10	1.8		Included fence (H), poor form (H), epicormic branching (M), bow (M), deadwood (L), appears to be shared	Remove
B	Manitoba Maple	<i>Acer negundo</i>	~18	P	P	PF	10	1.8		Included fence (H), poor form (H), epicormic branching (M), v-unions at base with included bark and included deadwood, deadwood (L), appears to be shared	Remove
C	Siberian Elm	<i>Ulmus pumila</i>	~34	P	PF	PF		2.4	1 / 2	Crook (M), included fence (M), poor form (M), epicormic branching (M), appears to be shared	Remove
D	Siberian Elm	<i>Ulmus pumila</i>	~36	P	PF	PF		2.4	1 / 2	Included fence (H), union at 2m with one lost leader, epicormic branching (M), poor form (M), appears to be shared	Remove
E	Siberian Elm	<i>Ulmus pumila</i>	~20	P	PF	PF		1.8		Included fence (H), asymmetrical crown (M), poor form (M), epicormic branching (M), appears to be shared	Remove

F	Siberian Elm	<i>Ulmus pumila</i>	~20	P	P	PF		1.8		Included fence (H), pruning wounds (M), poor form (M), crook (H) in crown, epicormic branching (M), appears to be shared	Remove
G	Manitoba Maple	<i>Acer negundo</i>	~16	P	P	PF		1.8		Included fence (H), v-union at 1.5m with one lost leader, epicormic branching (H), asymmetrical crown (M), poor form (M), appears to be shared	Remove
H	Manitoba Maple	<i>Acer negundo</i>	~20	P	PF	PF		1.8		Included fence (H), lean (M), poor form (M), epicormic branching (M), appears to be shared	Remove
I	Manitoba Maple	<i>Acer negundo</i>	~48	PF	PF	FG		3.0	1 / 2	Lean (H), poor form (M), epicormic branching (L), appears to be shared	Remove
J	Manitoba Maple	<i>Acer negundo</i>	~22, 20	P	PF	F		1.8		Union at base, poor branch unions with included bark, included fence (H), poor form (H), epicormic branching (L)	Preserve
K	Siberian Elm	<i>Ulmus pumila</i>	~36, 32, 14, 14	PF	F	F	15	2.4	1 / 2	V-unions at base, 0.5m, and 1.2m with included bark, deadwood (L), broken branches (L), included fence (M), appears to be shared	Remove

Image 1. From left to right, Trees A – F

The removal of 13 trees, including Trees A – I and K – N, is required to accommodate the proposed development. Trees A – H and N conflict with the proposed subsurface parking garage. Trees I and K – M have crowns that conflict with the second floor of the proposed development.

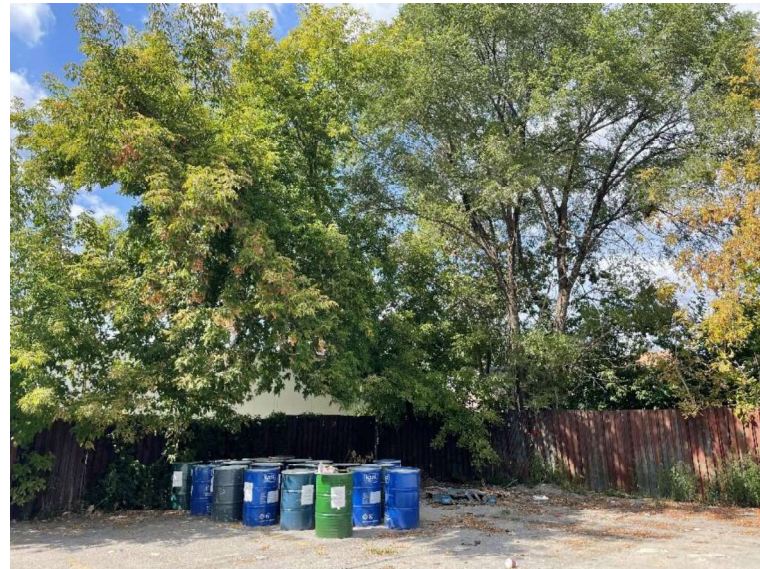
Image 2. From left to right, Trees G – I and K

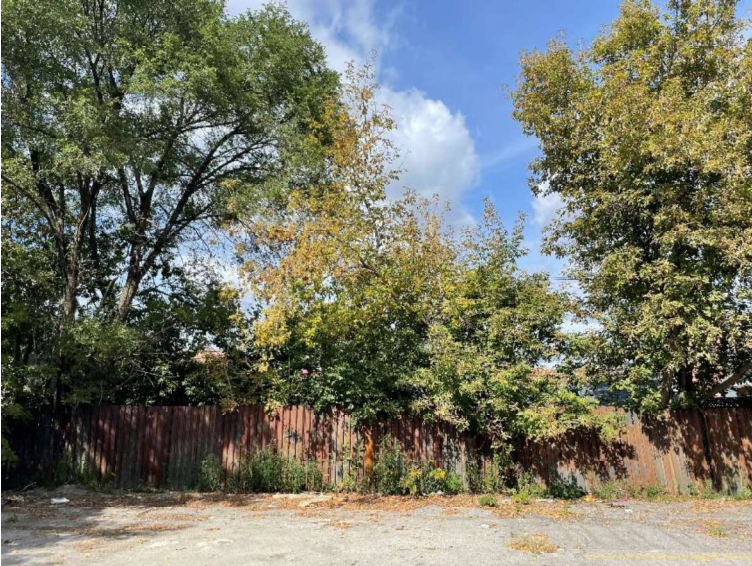
L	Manitoba Maple	<i>Acer negundo</i>	~28	P	PF	PF		1.8		Included fence (H), bow (M), pruning wounds (L), epicormic branching (M), poor form (M), appears to be shared	Remove
M	Manitoba Maple	<i>Acer negundo</i>	~24, 20, 20, 15	P	PF	PF	15	1.8		V-union at base with included bark, deadwood (L), included fence (H), poor form (M), epicormic branching (M), sun scorch (L), stem wounds (M) in crown, appears to be shared	Remove
N	Manitoba Maple	<i>Acer negundo</i>	~17	P	P	P	95	1.8		Included fence (H), crook (M), deadwood (H)	Remove

Image 3. From left to right, Trees K – M
