**Updated Hydrogeological  
Investigation – Proposed  
Development at 822, 828, 834,  
836, 838 Richmond Street West,  
Toronto, Ontario**

*Palmer Project #*  
2001512

*Prepared For*  
Watters Environmental Group Inc

November 04, 2021

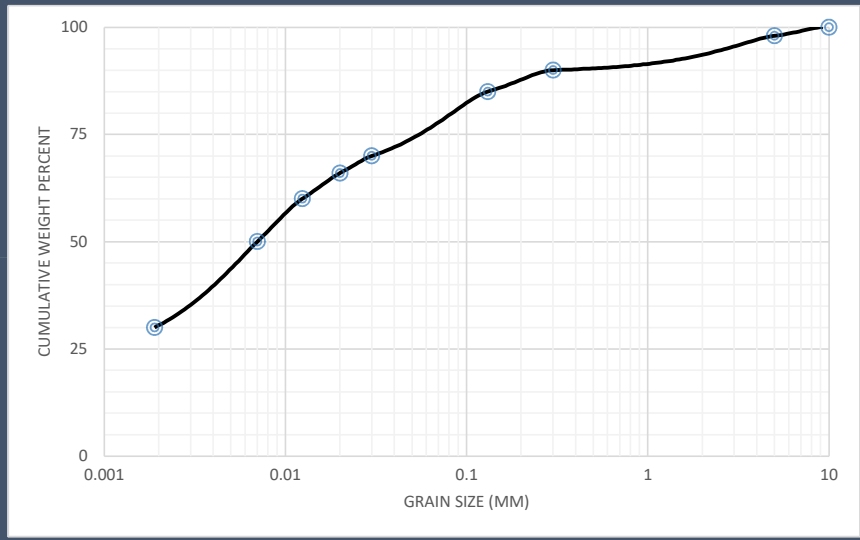
# BH103, S10

Silty clay, some sand, trace gravel.

Estimation of Hydraulic Conductivity	cm/s	m/s	m/d
Hazen	.243E-06	.243E-08	0.000
Hazen K (cm/s) = $d_{10}^2$ (mm <sup>2</sup> )	.401E-06	.401E-08	0.000
Slichter	.486E-07	.486E-09	0.000
Terzaghi	.710E-07	.710E-09	0.000
Beyer	.292E-06	.292E-08	0.000
✓ Sauerbrei	.149E-06	.149E-08	0.000
Kruger	.528E-04	.528E-06	0.046
Kozeny-Carmen	.379E-05	.379E-07	0.003
Zunker	.290E-05	.290E-07	0.003
Zamarin	.353E-05	.353E-07	0.003
USBR	.103E-06	.103E-08	0.000
✓ Barr	.526E-07	.526E-09	0.000
✓ Alyamani and Sen	.961E-06	.961E-08	0.001
Chapuis	.751E-09	.751E-11	0.000
Krumbein and Monk	.424E-04	.424E-06	0.037
geometric mean	.196E-06	.196E-08	.170E-03
arithmetic mean	.388E-06	.388E-08	.335E-03
